Restoring the MGA Factory Aluminium Hardtop

by Roger
Bailey

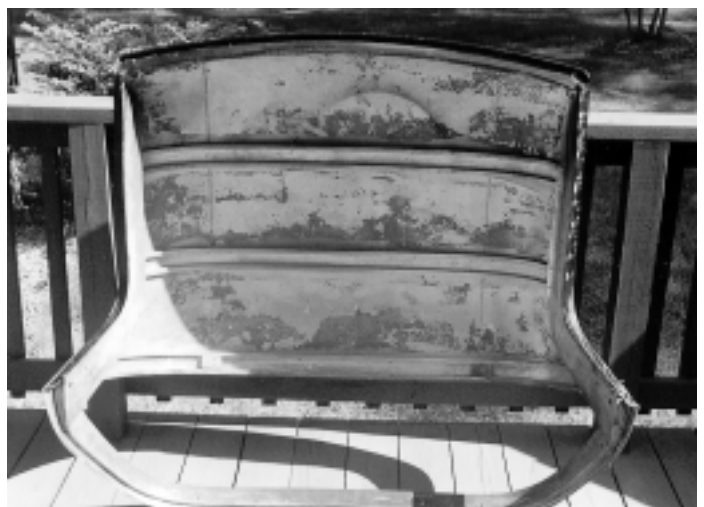
Stripped hardtop with some glue still to be removed

Next, I took off the sound-proofing/insulation sections glued to the roof between the roof bows. I wore a dust mask and eye protection to remove the old glue using the 3M fiber wheel. The dust was vacuumed off and the aluminum washed with a solvent. This sound deadening/insulating fiber was replaced with aluminum-faced heat insulating material from J.C. Whitney. (Incidentally, I also used this material for making a coupe-like bulkhead heat insulating pad – shhh! Don't tell the judges, but it makes for a really comfortable drive – especially if you have a hard-top.) The material was cut such that when glued with contact cement, metal side to the aluminum, there was a gap between the material and the wooden bows. You need this space to tack the headlining cloth "margin" to the side of the bows.

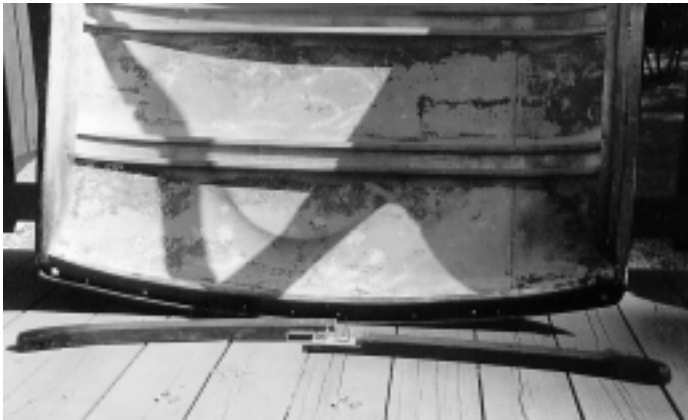
The method of splitting and rejoining the front bow.

Removing the front bow should not be attempted unless, as was my situation, the wing bolt nut was stripped on one side of the bow, and the supporting wood was rotted away on the other end. If threads alone are the problem, by all means try Devcon thread restorer before taking the bow out. Removal of this bow was very difficult because it was clearly built in as the hardtop was fabricated. The curvature of the roof and the aluminum side panels conspire to block removal. To get it out required a somewhat frightening bending of the aluminum side panel, but was aided by the wood rot at the end of the bow. Putting the bow back in seemed impossible without splitting it in two, and even then the task was no breeze. I removed all old nails and restored the bow, then cut the bow with a tenon saw, making a lap joint. The horizontal kerf must be shimmed back to produce the original bow thickness; I used a piece of plastic. Two ¼-20 bolts were used to re-fasten the joint. The inner lap was drilled and tapped, while a clearance hole was drilled in the outer lap and kerf shim. The bolt heads were slightly countersunk into the wood, and the metal ground flush with the surface. The threaded section extends only far enough to allow the washer, lock washer, and nut to be attached. The two sections were now installed and bolted together. The bow was re-fastened through the windshield lip with small countersunk wood screws.
