From the Frame Up, LLC

Tech Tips:

AC120 – OIL CAN & BRACKET INSTALLATION

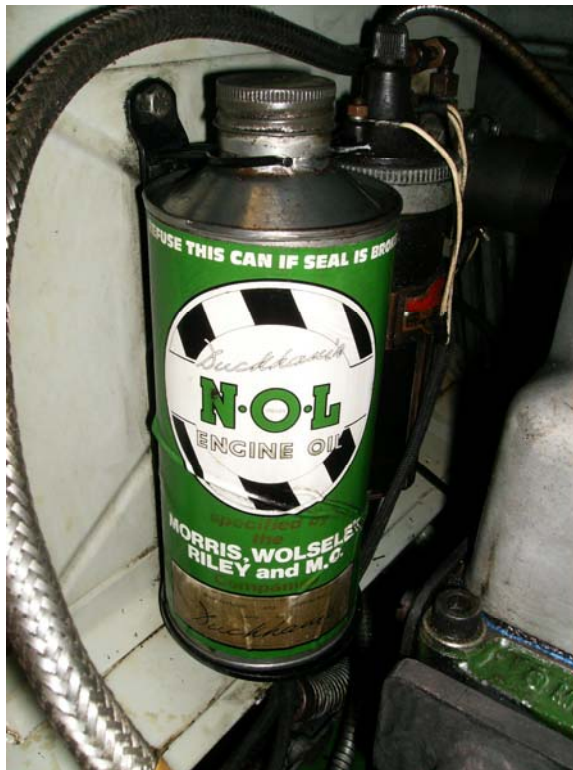
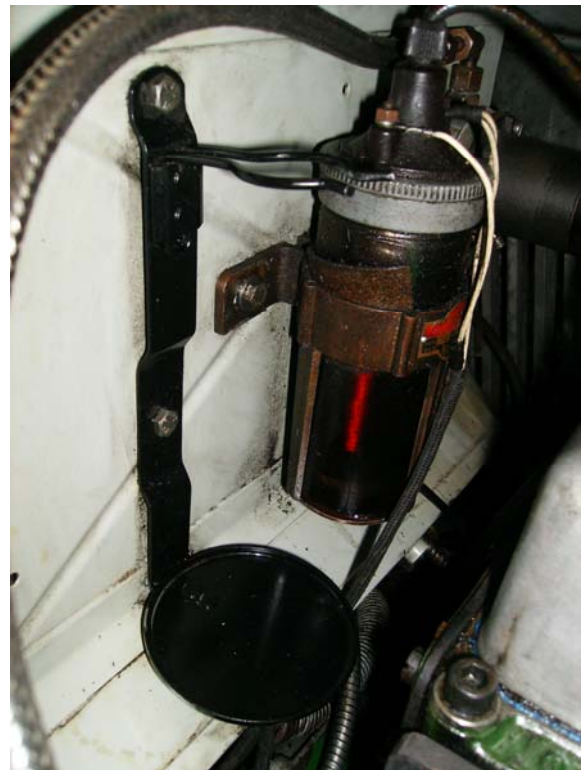
Below are photos of the oil can and bracket. Additionally, a template is provided on the next page to assist in sighting the proper location of the bracket. This template was provided by the Whitworth Shop in Ohio.

Although the oil can and bracket are listed as an accessory, they were actually factory installed original items. Overall, the oil can and bracket are proper for most all but not every TC.

The very early TC's did not have the oil bracket. The first reported sighting is on TC0488, so it appears that the first 1-200 cars may have not had this item. Approximately Sept 1948, the oil can was eliminated on those cars slated for export to include the EXU's. However, this is not absolute for all exports except the EXU. The EXU could not install the bracket due to conflicting EXU equipment (wire harness for the horns)
